Conversion of a natural gas pipeline to hydrogen transport and the effects of impurities on the hydrogen quality

DNV – Henk Top
Groningen, The Netherlands

Thursday May 19th 2022 Energy Transition S3-1

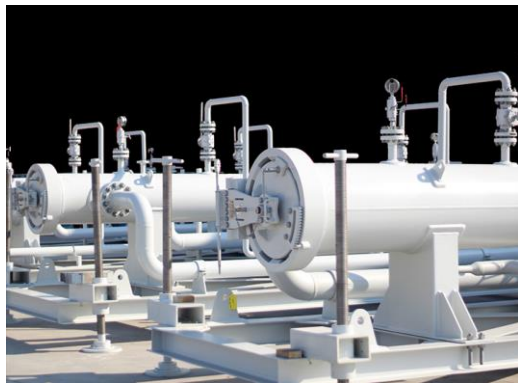
Photo: Pig launcher/receiver Ergil

The existing 16-inch section of the natural gas pipeline was examined using internal Magnetic Flux Leakage (MFL) inspection in 2017. This is a widely used non-destructive testing method for the detection of (internal) corrosion and pitting in steel structures. Before this inspection the natural gas pipeline was cleaned by means of a bi-directional (BIDI) cleaning pig. Approximately 5 litres of sludge (not analysed) came along at that time. Sludge found in natural gas pipelines normally consists of a mixture of natural gas condensates, lube oil and glycol.

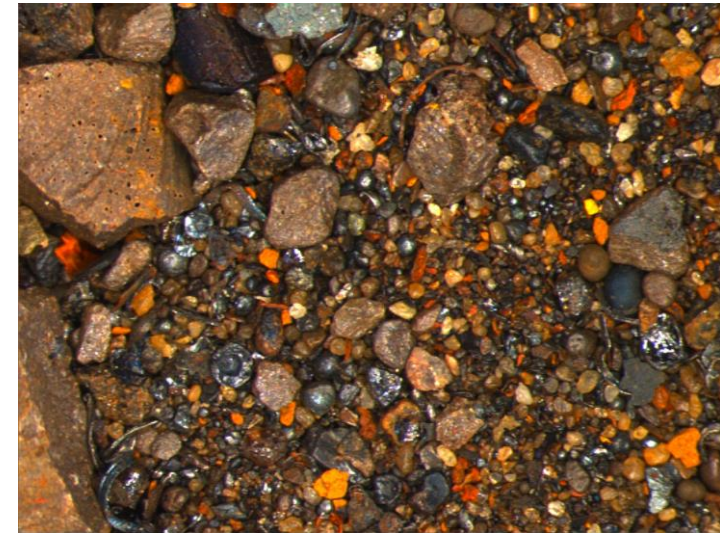
SEM-EDX analysis debris

Scanning Electron Microscope (SEM)-Energy-Dispersive X-ray (EDX) results:

- Minerals
- Rust particles
- Iron oxide balls (welding and grinding)
- Chips of low alloy steel

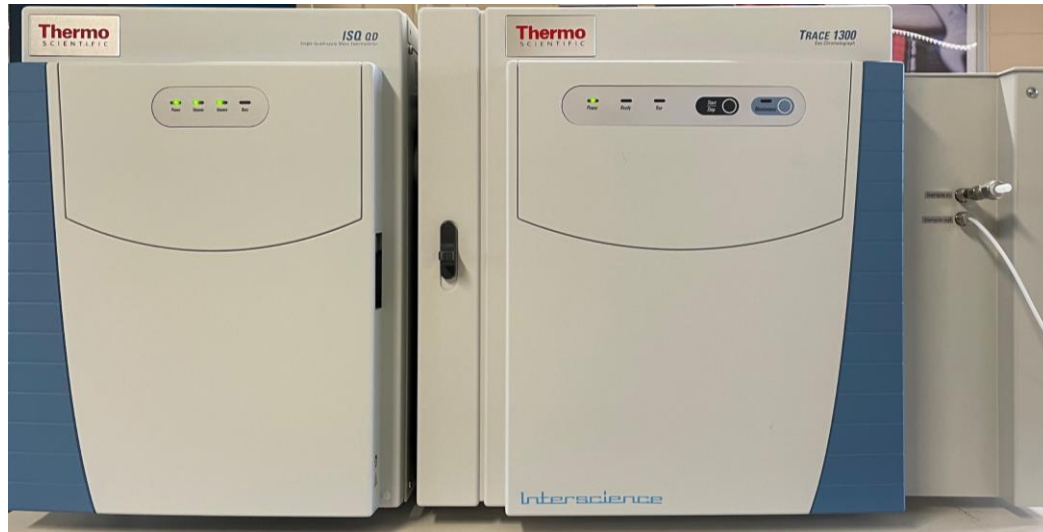
Thermo Scientific Trace 1300 Gas Chromatograph with a Flame Ionisation Detector and a Mass Spectrometer ISQ (single quadrupole) in parallel

Screening unknowns in mass range 20 – 400 amu

GC/MS system DNV, delivered by Interscience

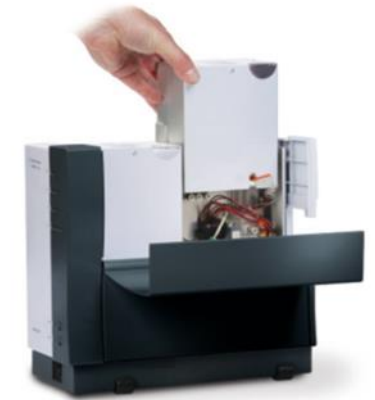
tetrahydrothiophene (THT)

THT (TetraHydroThiophene) odorant was analysed with an Agilent Technologies 490 PRO micro-GC.

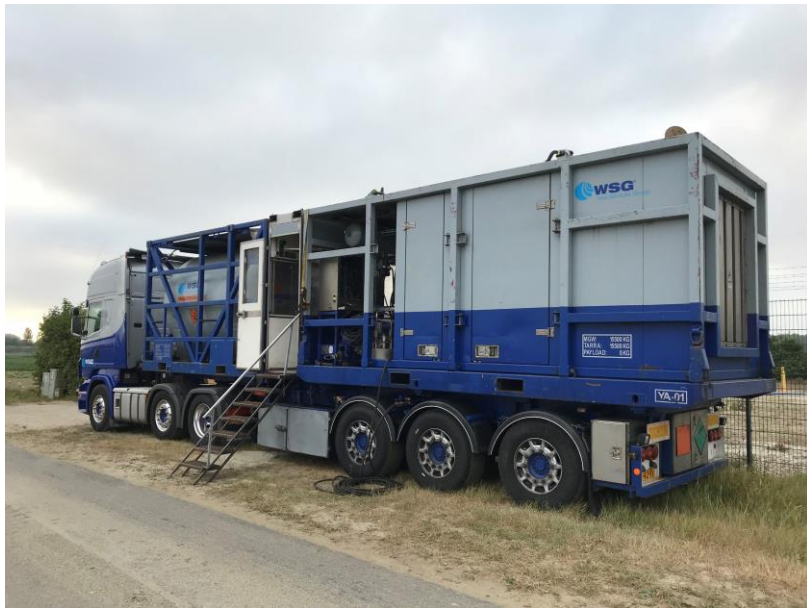
Nitrogen unit WSG

Following an investigation into the residual products in the converted pipeline, which will eventually transport hydrogen, it was found that a number of components have relatively high values. It was decided to purge with nitrogen at one side and to vent it on the other side of the former natural gas pipeline. DNV was asked to monitor this process using a water dewpoint sensor, a flame ionization detector (C_xH_y) and a micro-GC.

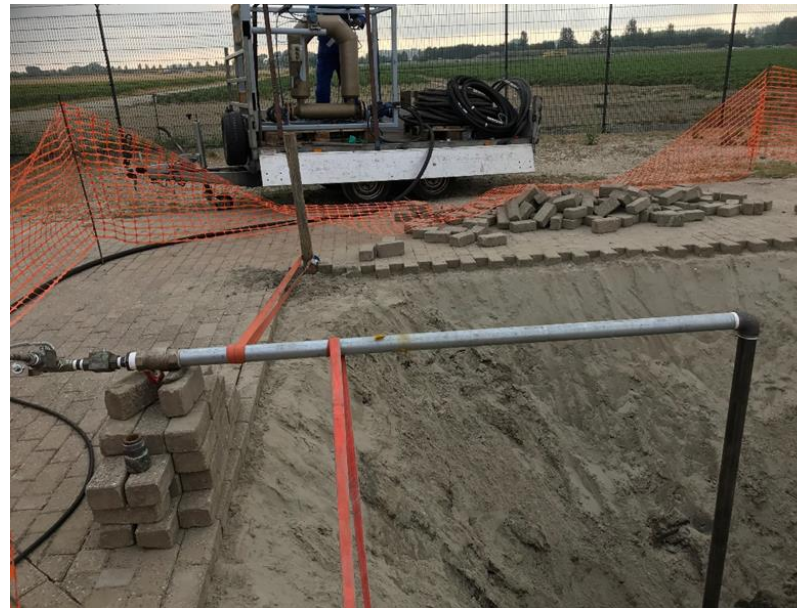
Nitrogen injection DN50 + Coriolis flowmeter

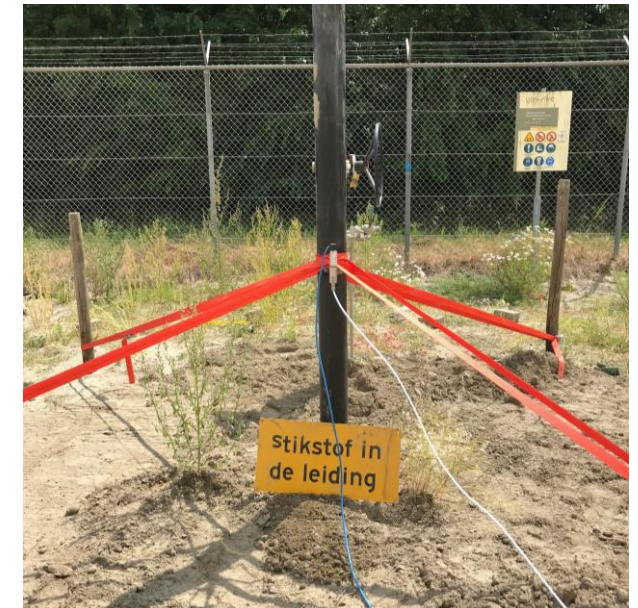
Nitrogen vent DN100 + sampling DNV
